# Manhole Inspection Summary

Manhole # S69M\_\_024MH

**Location** Address: **6608 O'Donnell St.**

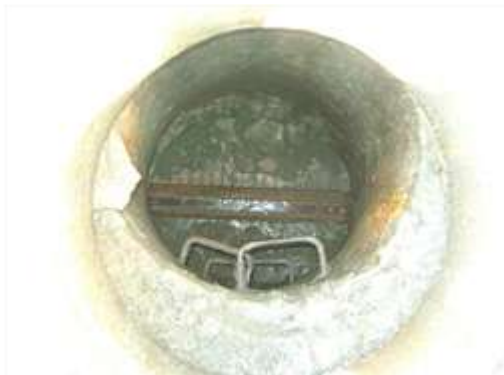
Defect 1

O12

pipe offset defect

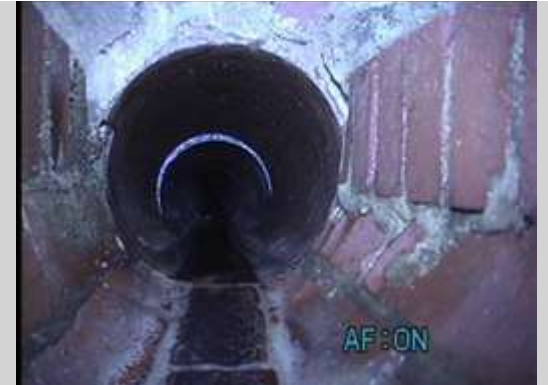
12 O'Clock Outflow

8 in. Circular Gravity Sewer  
Pipe Out @ 12 O'Clock

Pipe Height: **8.4** (in.) Rod and Bar (Angled)  
Pipe Material: **Clay** ☐ Pipe Lined  
Invert Depth: **9.08** (ft.) Flow Characteristics: **Slow**  
Deposits: ☒ None ☐ Mud ☐ Sludge ☐ Debris ☐ Grease  
Silt Depth: (in.) Deposits Extent:  
Infiltration: **None** Pipe Seal Cond: **Sound**

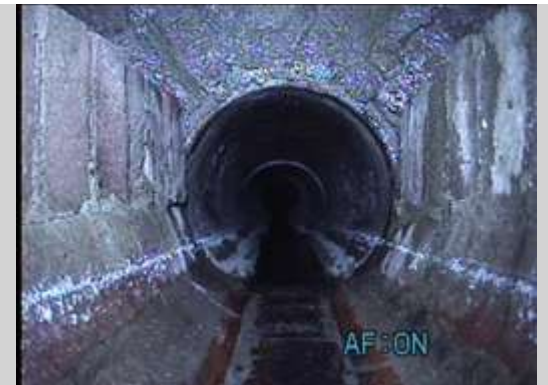
6 O'Clock Inflow

8 in. Circular Gravity Sewer  
Pipe In @ 6 O'Clock

Pipe Height: **8.4** (in.) Rod and Bar (Angled)  
Pipe Material: **Clay** ☐ Pipe Lined  
Invert Depth: **8.96** (ft.) Flow Characteristics: **Slow**  
Deposits: ☒ None ☐ Mud ☐ Sludge ☐ Debris ☐ Grease  
Silt Depth: (in.) Deposits Extent:  
Infiltration: **None** Pipe Seal Cond: **Sound**
